TTI Performance Exhaust and Headers  
Tube Technologies, Inc.  
Corona, California 92880-1726  
Phone (951) 371-4878

Sheet #101 / Footnote #36

### 3-section throttle rod swivel assembly modification

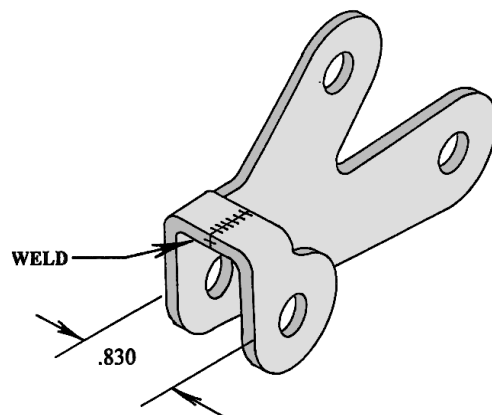
Applications with a 3-section throttle rod may require modification to the bell-crank and the pivot shaft to clear the header tubes or exhaust pipes.

1. The bell-crank and the pivot shaft must be shortened by 3/4".
2. Weld the bell-crank back together as shown.
3. Re-bend the lower throttle rod as shown.
