Sheet #7174TSA / Footnote #6

TORQUE SHAFT ASSEMBLY
71-74 B-body & 70-74 E-body
Column Shift applications

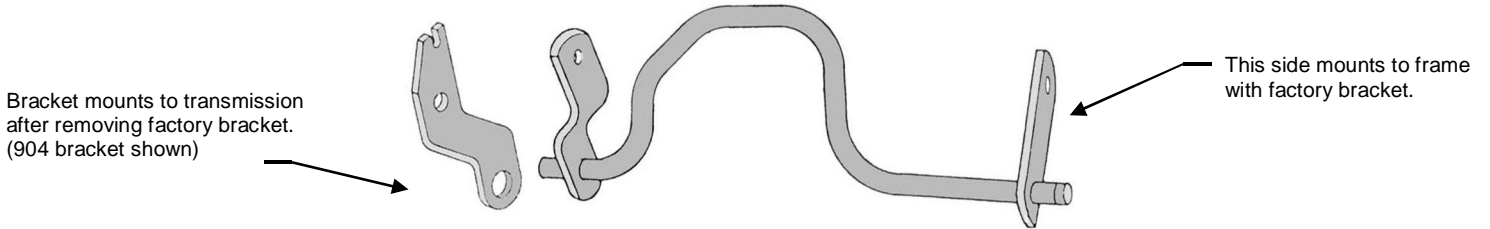
This precision bent Torque Shaft Assembly with laser cut ends go up and over the Header tubes or Exhaust Pipe which allows you to maintain your column shift linkage and is a direct bolt-on replacement of your stock straight torque shaft rod.

Transmission: 727 P/N: B7174TSA-7 (Narrow bracket), 904 P/N: B7174TSA-9 (Wide bracket)

Due to various manufacturing designs of the column shift linkage in some 71-74 B-body and 70-74 E-body vehicles, you may require a TTi modified design Torque Shaft Assembly. A Torque Shaft Assembly is required if the Drivers-side stock straight torque shaft rod is mounted below the torsion bar. The stock straight torque shaft rod passes directly through the space where the Header tubes or the Exhaust Pipe (to manifolds) must go.

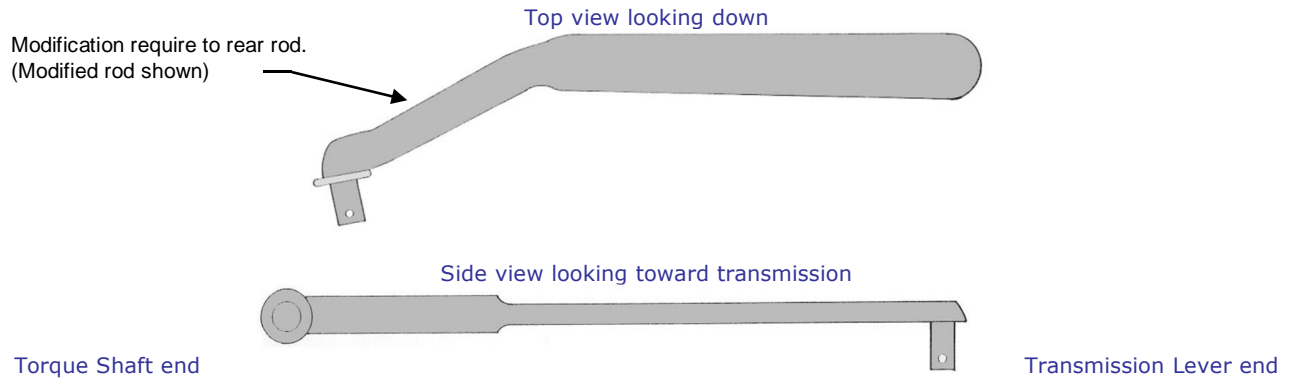
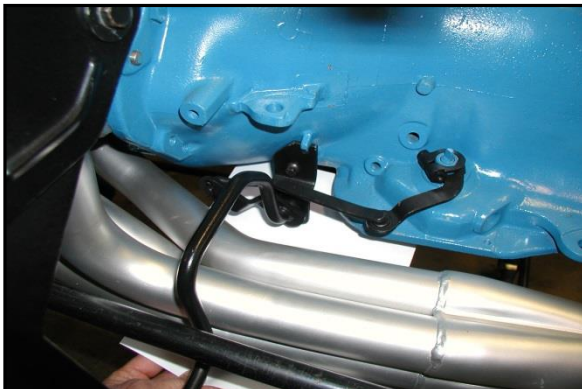
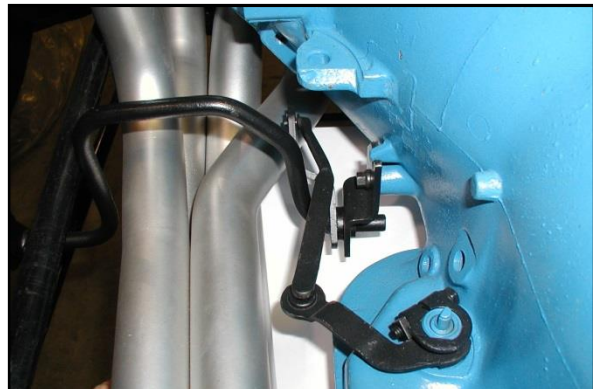
Rear rod transmission to Torque Shaft Assembly
